Samuel McKinstry Mill House McKinstry's Mill

Maryland Historical Trust State Historic Sites Inventory Form

1. Nam	(indicate pre	ferred name)		· ·		
					· · · · · · · · · · · · · · · · · · ·	
historic Sam	uel McKinstry Mill H	ouse				
	Zumbrun House					
2. Loca	ation					
street & number	1498 McKinstry Mil	1 Road			not for publicati	ion
city, town McK	instry's Mill	vicinity of	congressional di	strict		
state Marylar	nđ	county	Carroll

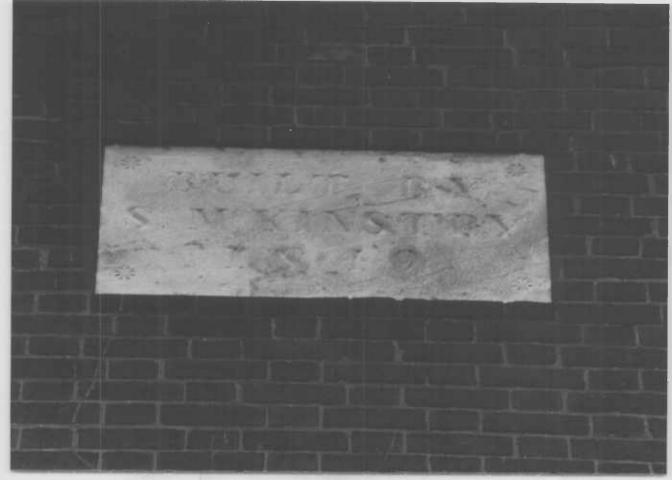
The north elevation has Flemish bond brick. The foundation on this side is not exposed. Both the first and second stories have two typical 6/6 sash, one on each end. The gable end has two four-light sash in bullnose frames with marble sills. Over the window frames is a header course. There is a marble date placque centered in the gable end. It is carved "Built by S.McKinstry 1849". In each corner of the placque is a carved rosette.

CARR-75 and McKinsty Mill House 1498 McKinstry's Mill Rd. Carroll County, Maryland Photo: Kenneth in Short nate: Aug. 1994 Neg. Loc .: Maryland Historical Trust north elev. - date stone 4/12

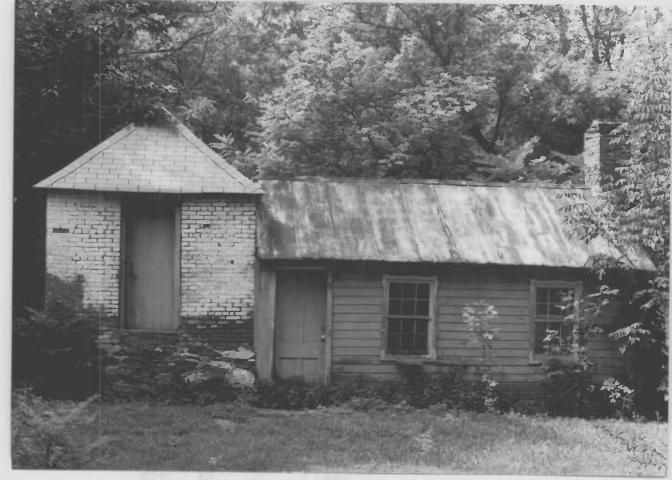
The summer kitchen on the west side of the smokehouse is a one-story, three-bay by one-bay structure of German siding with corner boards and a gable roof of corrugated metal with an east-west ridge. There is an exterior brick chimney on the west end. The north elevation has a four-panel door to the east and two 6/6 sash to the west with jigsawn-trim surrounds. The west and south elevations have no openings. The building is constructed of 2×4 's. The fireplace on the west end has a segmentally-arched opening with two round steel bars acting as lintels under the arch. The fireplace has straight jambs and a pivoting crane on each side. About 60 feet southwest of the smokehouse is a hog pen with vertical-

CHRR-75 Samuel Mi Yensty Mile House 498 MCY: sty war 20. Carrier County, maryland Photo porte in Sel Date: July 1714 19 Loc. Maryland Historical Trust smotcheuse summer Kitchen-north elev

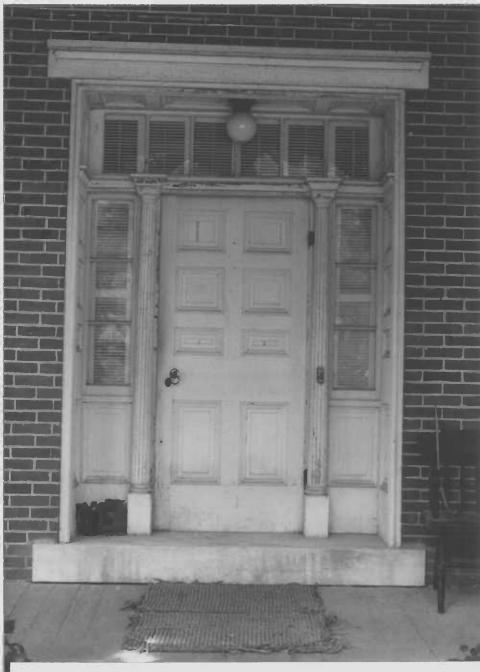
CATAL 15 Samuel Mikinsty mill Home 144x Mc Kinsty's mine RQ. Carrett County, Maryland Photo Kenneth in Shot Date July 1994 Neg Loc Mayland Historice Trust cast door way

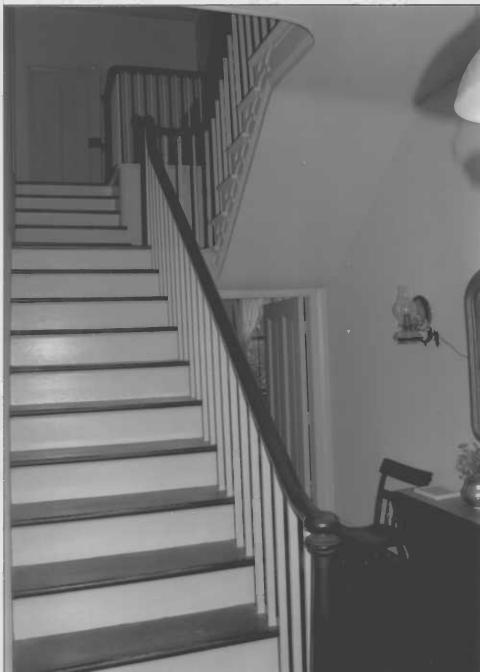
The newel post passes through the floor about one foot. It has a rectangular shank on the bottom that is narrower than the dimension of the post above the floor. This rectangular shank has a hole cut through it, with a wedge-shaped piece of flooring hammered into the hole which wedges it tight against the bottom of the floor. In front of the newel are two holes that are now plugged. There are circular marks on the front of the newel post as if there was a crank here that turned. Underneath the floor, attached to the bottom of the newel and underneath the two holes in the floor, are two pulleys. Apparently, there was some sort of control for the furnace that once stood in the cellar under the east end of the passage. Presumably, the crank was attached to wires that ran through the floor, around the pulleys, and to the furnace, possibly to open and close a duct.

CARR-75 Danuel McKinstry Min House 1498 McKinstry's Mill Rd. Carroll County, Naryland Photo: Kennett m. Short Date: June 1995 Neg Loc.: Maryland Historical Trust 1st Story Stairway

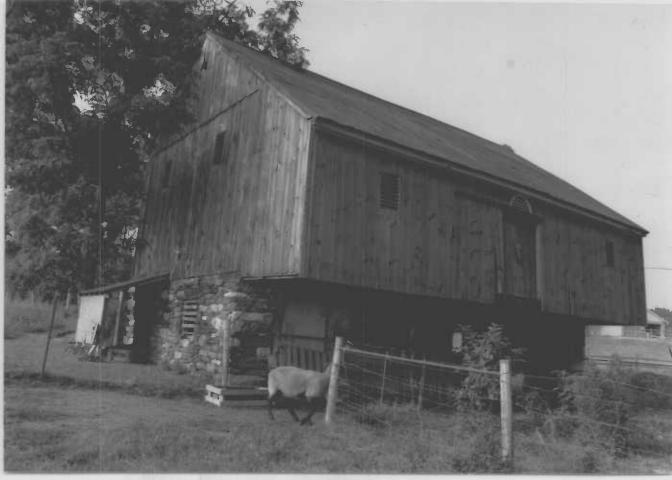
About 30 feet northwest of the garage is a bank barn with a forebay that faces south. The south elevation on the lower story has vertical-board siding. From west to east there is a new door, a wood louvered vent, a door opening with pintles, a wood louvered vent, and a vertical-board Dutch door on strap hinges with rounded ends. The upper story has one vent on each side with a pair of doors in the center that has a semi-circular wood louvered vent above it. The southern ends of the joists under the forebay are notched on the top to hold the sill, which is pegged to some of the joists. The west elevation has a rubble stone lower story with a door opening to the north and two window openings to the south. There are two wood vents in the upper story with a round opening cut in the peak. The east elevation has a boarded-up window to the south and a new door in an original opening to the north in the lower story. The upper story has two wood vents, with a round wood louvered vent in the gabled peak. The north elevation has vertical-board siding. The gable roof has corrugated metal and an east-west ridge. The upper story has centered double wagon doors that are new, and an outshot attached to the east end of this elevation.

CAKK-75 Samuel McKinstry Mill House 1498 mc Kinstry's Nill Rd. Carroll County, Maryland Pluto: Kenneth m. Short Date: June 1995 Neg Loc. Maryland Historical Trust bourn

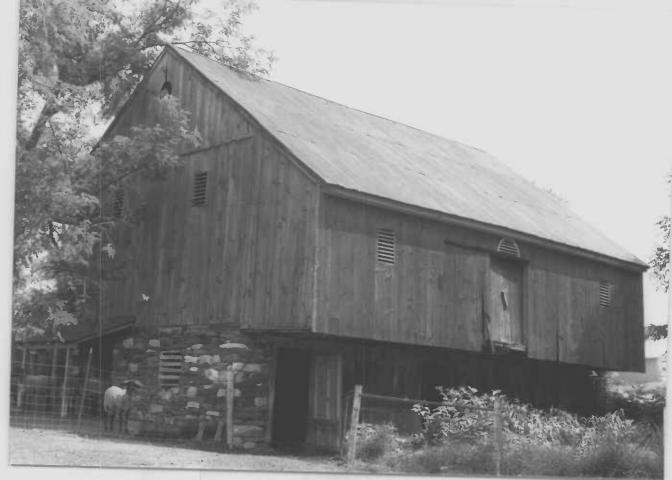
CHED 15 Samue me Kunstry Miss House 1498 McKinsty Well Rd. Caroli Conty Maryland Ploto Youth In Stort Date July 194 Negloc: may pland thistorical Trust barre He west ends
